**MARYLAND HISTORICAL TRUST
DETERMINATION OF ELIGIBILITY FORM**

Property Name: Zeiler-House and Barn Inventory Number: CARR-1699
Address: 401 Blizzard Lane Historic district: ☐ yes ☒ no
City: Westminster Zip Code: 21157 County: Carroll
USGS Quadrangle(s): Westminster
Property Owner: State of MD's Dept. of Natural Resources Tax Account ID Number: 027175
Tax Map Parcel Number(s): 58 Tax Map Number: 167 (59.72 Ac.)
Project: DNR Documentation for Razings Agency: Department of Natural Resources
Agency Prepared By: Historic Preservation Consultant
Preparer's Name: Catherine Masek Date Prepared: 12/2/2008
Documentation is presented in: MIHP form for Zeiler House and Barn (Frick Farmstead) by Catherine Adams Masek, 2008 and
NIHP form for Morgan Run NEA by Goodwin & Associates, 2004.
Preparer's Eligibility Recommendation: ☐ Eligibility recommended ☒ Eligibility not recommended
Criteria: ☐ A ☐ B ☐ C ☐ D Considerations: ☐ A ☐ B ☐ C ☐ D ☐ E ☐ F ☐ G
Complete if the property is a contributing or non-contributing resource to a NR district/property:

Zeiler House and Barn

CAPSULE SUMMARY

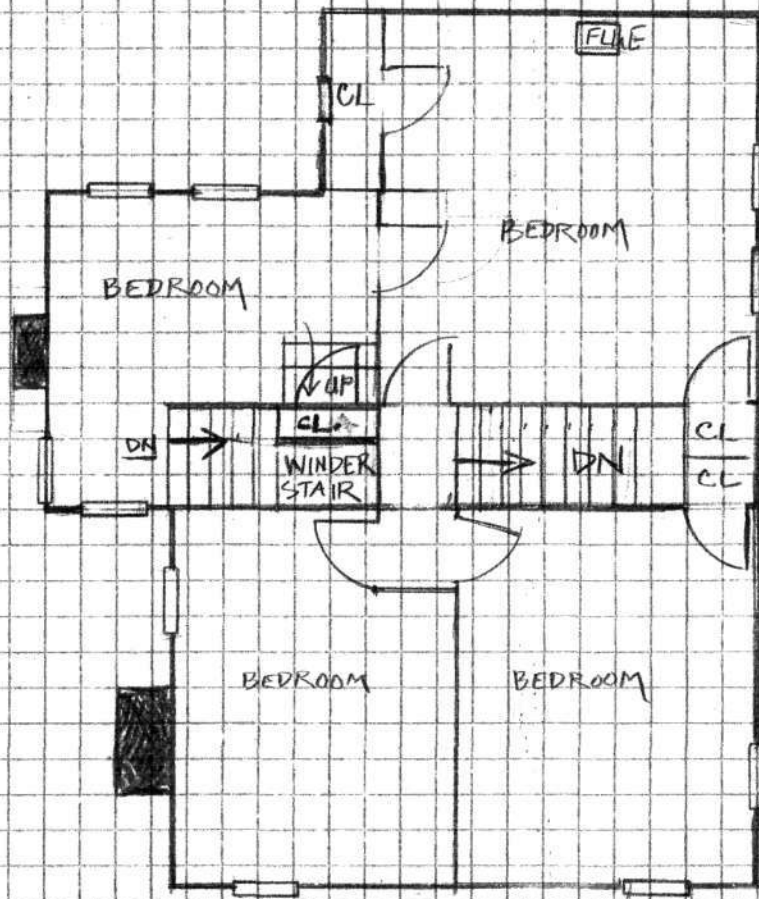
CARR-1699-ZEILER HOUSE+BARN
 (ZEILER FARMSTEAD)
 BLIZZARD LANE, OFF SYKESVILLE RD
 GAMBER VIC, MD CARROLL CO.
 SECOND FLOOR PLAN-HOUSE
 SCALE: $\frac{1}{8}'' = 1'$
 DRAWING: AUG 30, 2008
 CARROLL CO.

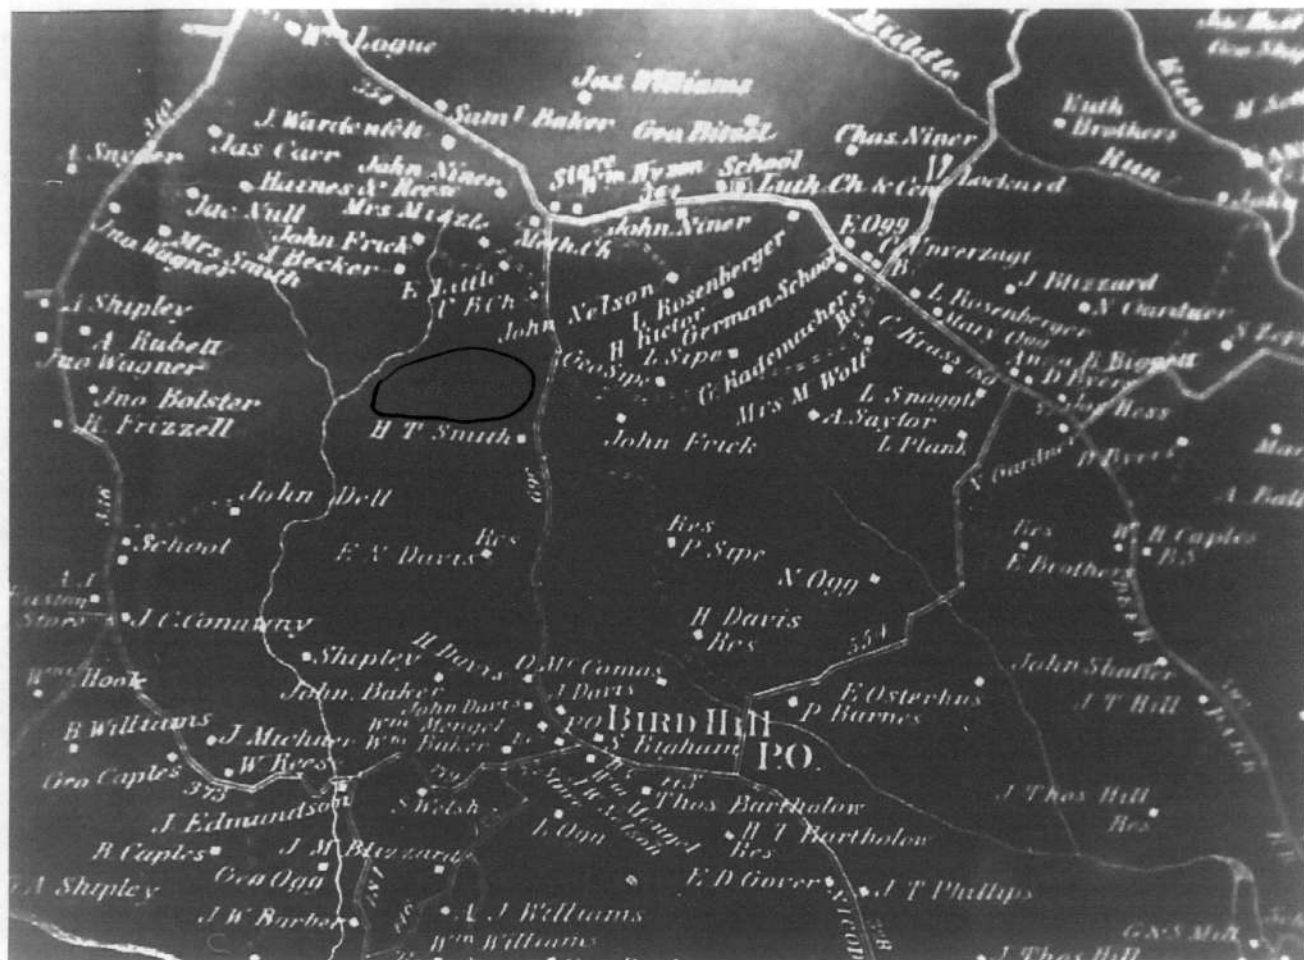
PHOTOGRAPH OF LAKE, GRIFFING & STEVENSON'S ILLUSTRATED ATLAS OF
CARROLL COUNTY, 1877. RUFUS FRICK, OWNER AS OF 1872,
IS NOT SHOWN AT ZEILER HOUSE AND BARN PROPERTY IN 1877

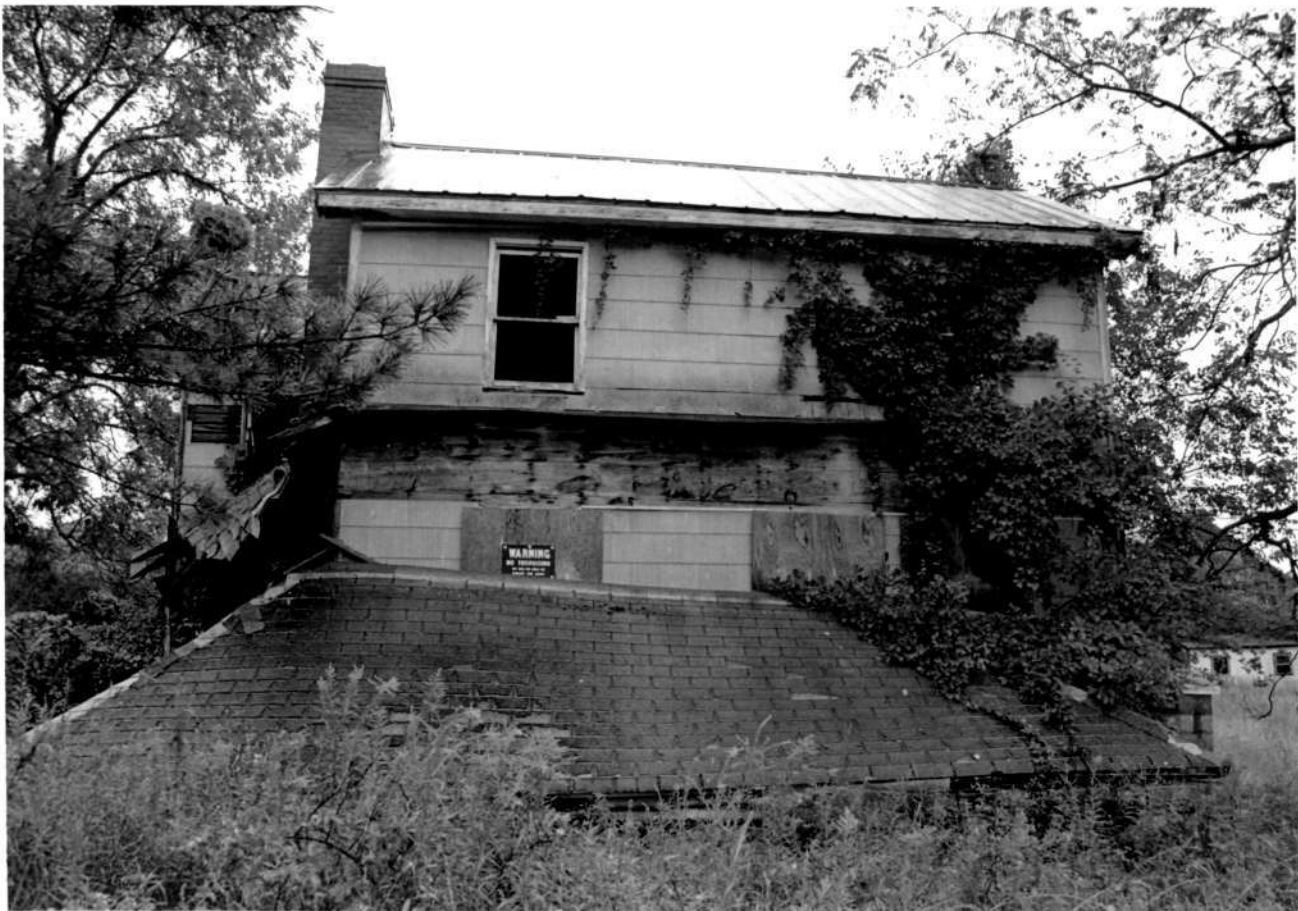
1 OF 9

NORTH FACADE

On the north façade, which is closest to the historic entry lane, there are four bays at first floor level, all of which are boarded/ covered. In the fourth bay from east or left is a 4-panel (vertical) wood door with hood, now covered with asbestos shingle. The northeast corner, which is the lowest point of the house, topographically, features a partially exposed fieldstone basement. A shed roofed concrete shed attachment near the northeast corner, on the north façade, between the first and second bays, leads to the basement via four concrete steps and a four panel (horizontal) door. Three windows exist at second floor level on the north façade.

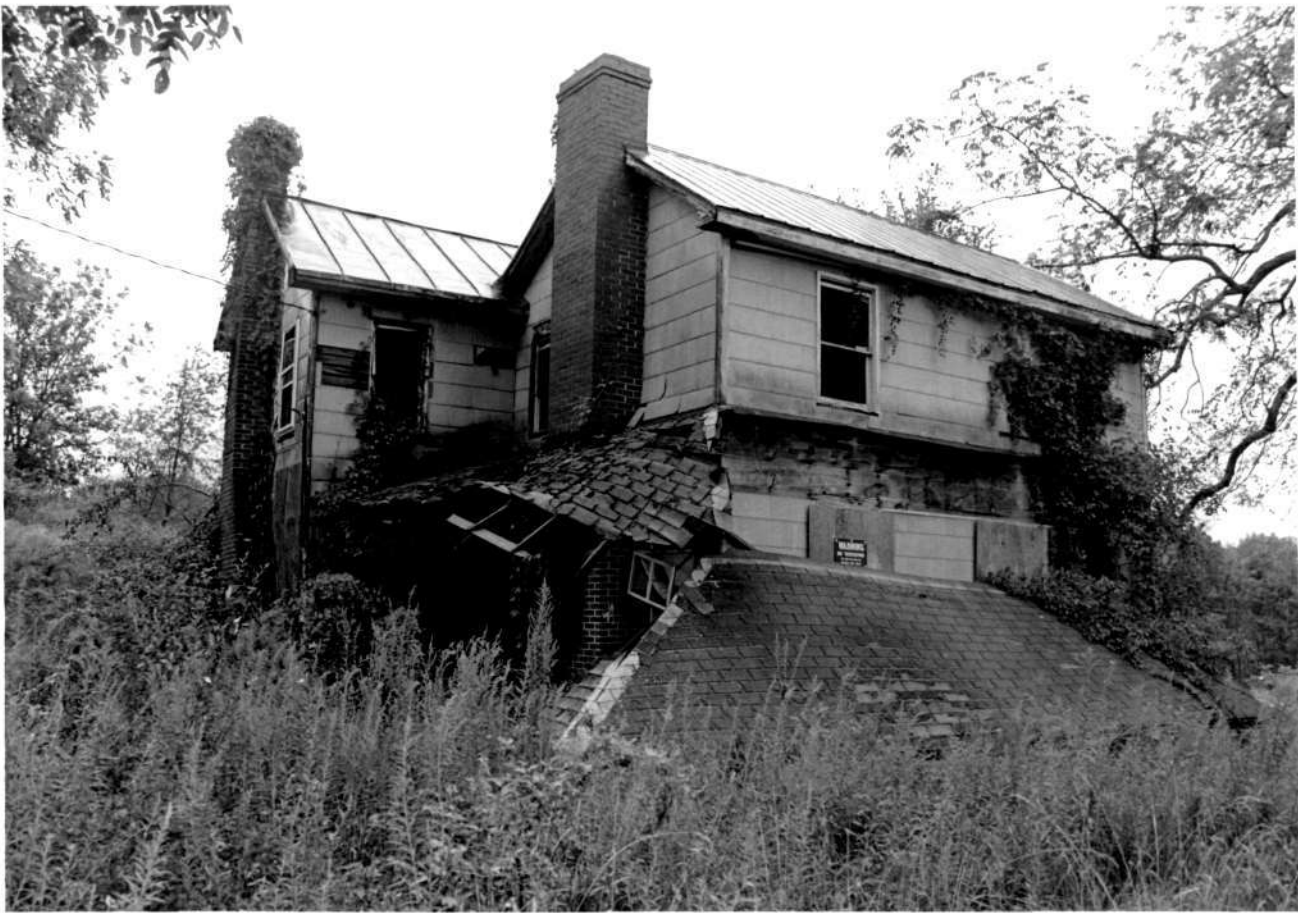
2 OF 9

NORTH(FRONT)+EAST(SIDE) FACADES

On the east or front façade, there are two bays on the 2nd floor and three bays (modifications evident) on the first floor. First floor openings are totally boarded/ covered, but one doorway is apparent in the second bay from right on east façade. A concrete floored one story porch with asphalt shingle roof is located on east (front), and wraps around to the south (side) facades, but this feature has totally collapsed to the ground. The fallen porch roof now blocks all east openings.

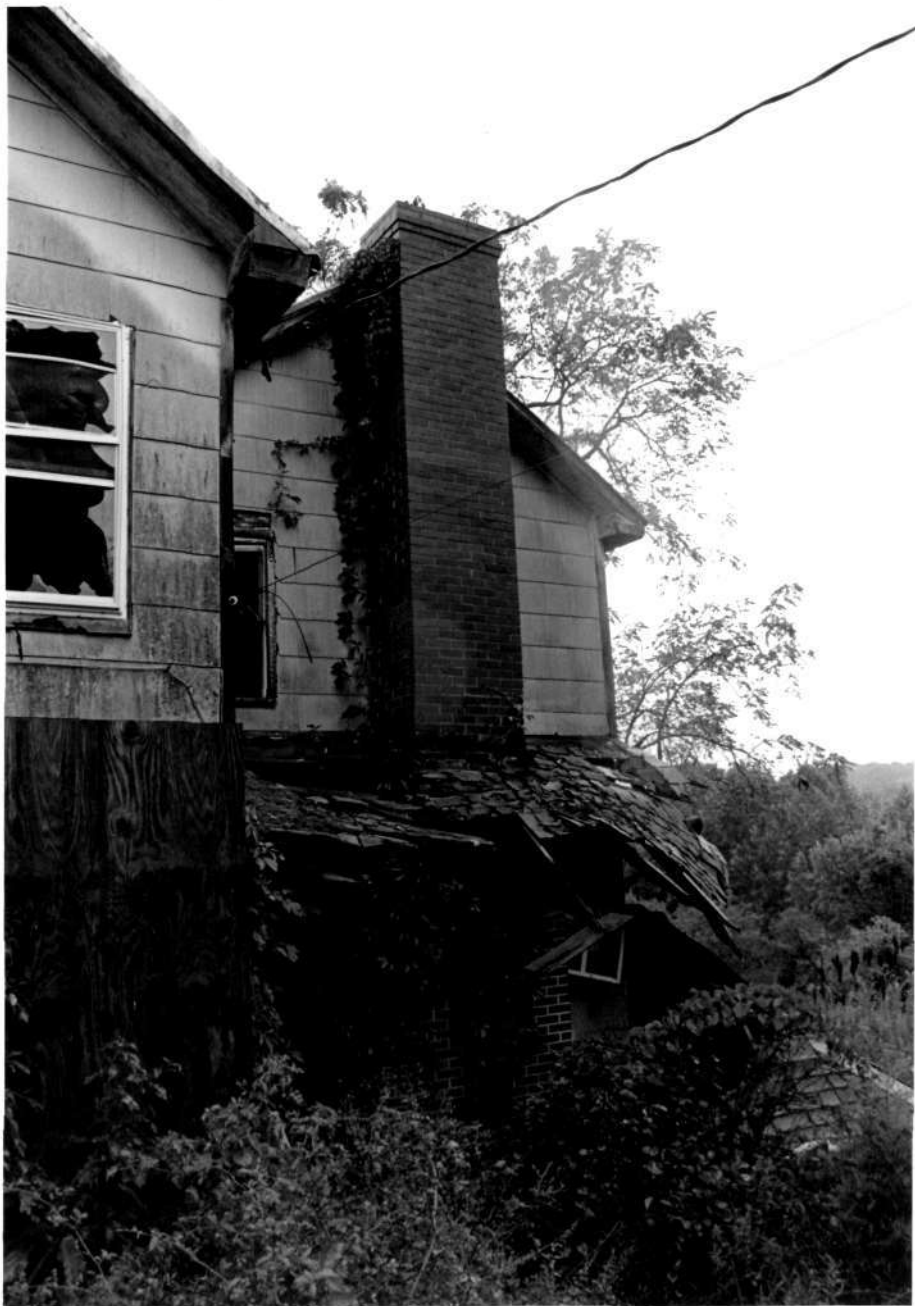
3 OF 9

DETAIL-EAST FACADE

On the east or front façade, there are two brick steps approaching the concrete floored front porch from the north. Underneath the collapsed porch roof resting on the porch floor and impacting all first floor east façade openings, there appears to be one concrete step leading from the concrete porch floor to the interior. There is a small two paned window replacing a double hung sash adjacent to the south room's fireplace, which was rebuilt in the 20th century with new brick and mortar. The first floor room to the west of the entry (in the west two story gable roofed wing) contains a straight staircase to the second floor (which runs north to south) and walls are covered with unfinished plywood sheets. There is no historic plaster or interior woodwork in this room. There is a simple exterior door frame with a four (vertical) paneled door and a plain deteriorated water damaged brick fireplace flue for stove attachment. A doorway (without door) leads south to the kitchen addition.

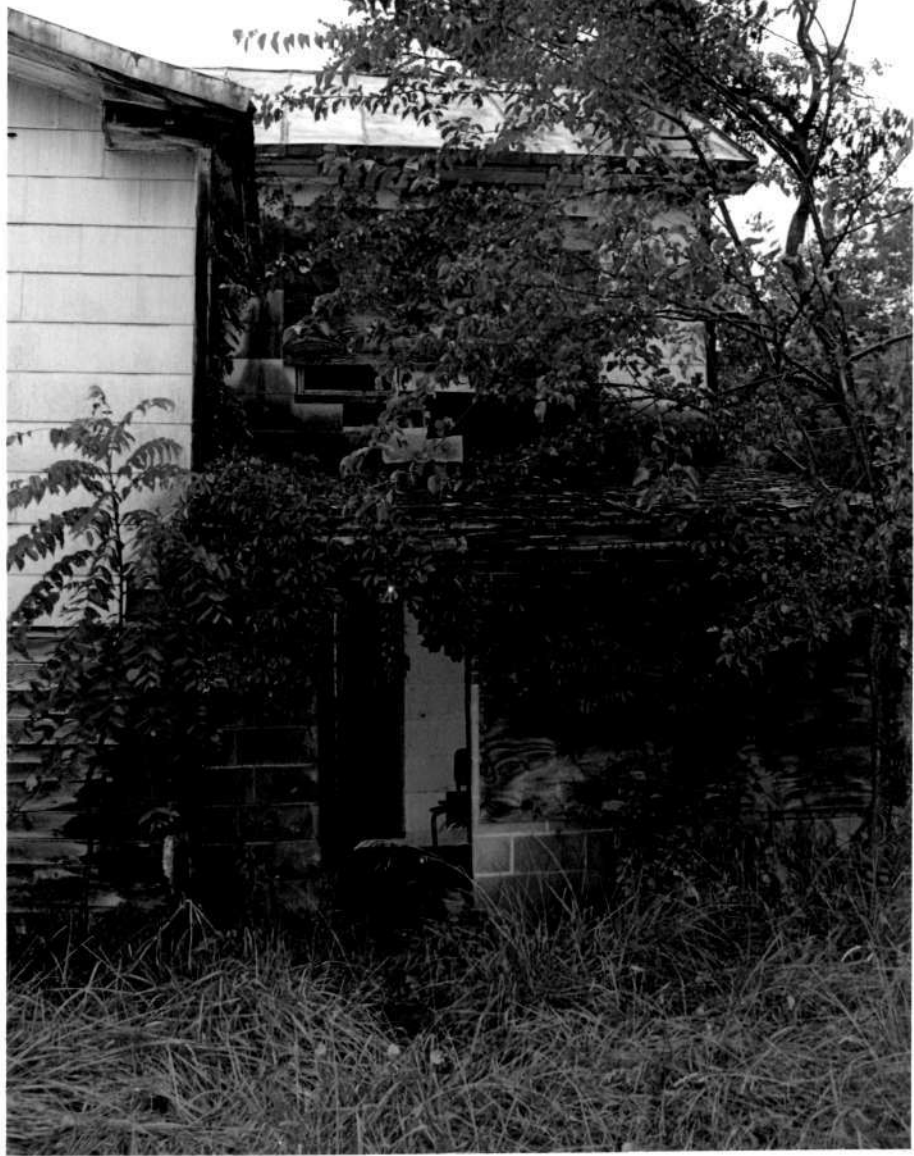
5 OF 9

DETAIL - SOUTH (REAR) FACADE

On the west (rear) façade, there is considerable water damage and collapse evident. There are two window openings in the left two bays, one missing glass, one completely boarded/ covered. The southwest corner (abutting the concrete block addition) has warped/ damaged/ wet siding. Foliage/ trees grow in this corner of the building. A moss covered, concrete block, shed roofed, one story addition is located in the southwest corner of the house. Topographically, the land slopes abruptly into this corner of the building, and therefore, this corner of the building appears to have retained wetness. A doorway (without door) enters the concrete block, dirt floored addition.

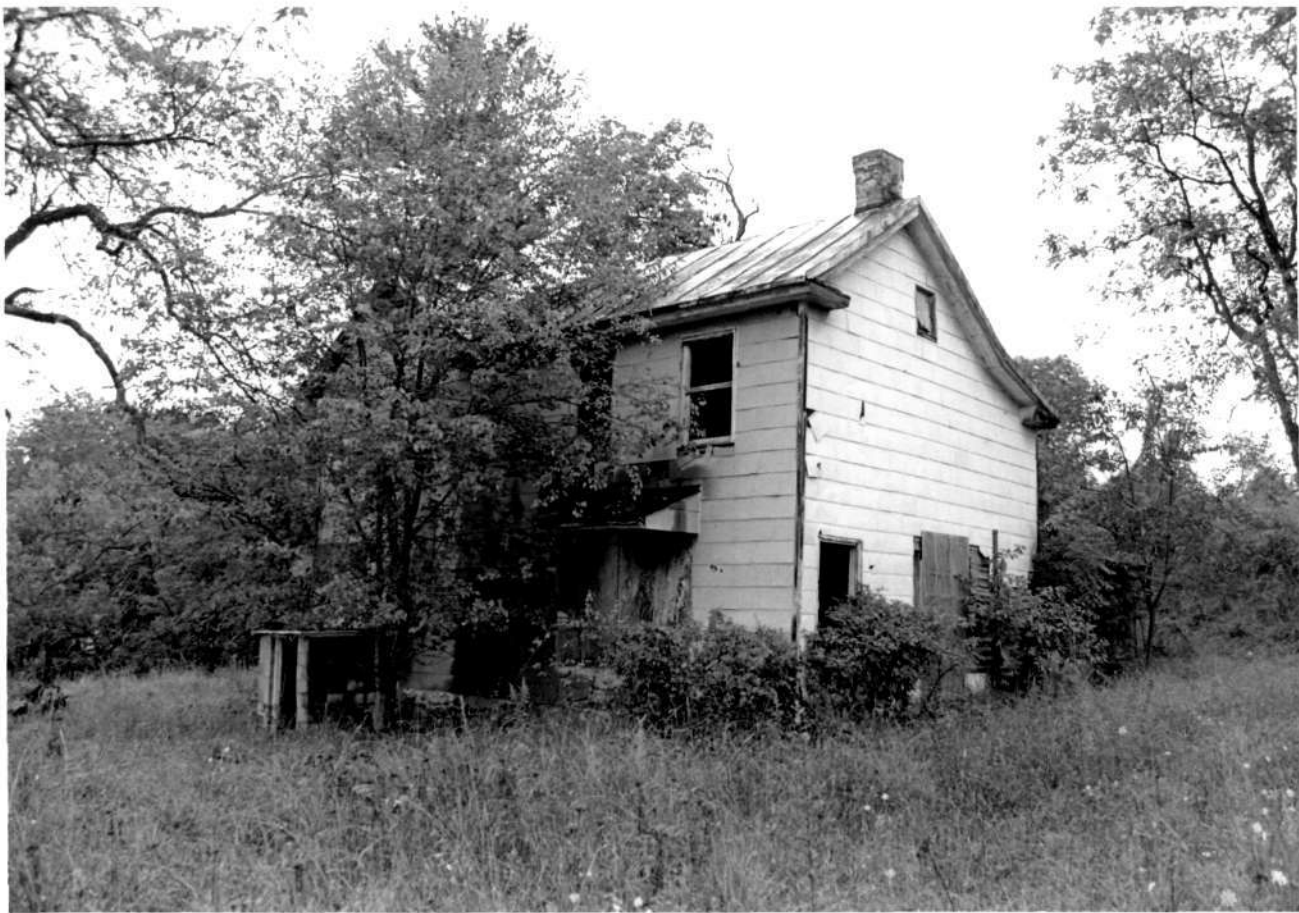
6 OF 9

SOUTH (REAR) + WEST (SIDE) FACADES

The west façade, also affected by foliage/ vines and wetness, features the gable end of the kitchen addition (with winder stair), and the gable end of the front or east section of the house. The entire kitchen wing appears to slope/lean to the southwest, affected by water damage at open roofline soffit and at all four second floor window openings. There is an exposed brick chimney in both gable ends. The collapsed porch roof has fallen on the exterior chimney of the front section. The porch floor is wood on the west façade and it has also collapsed under the collapsed porch roof. Three second floor window openings, one on each gable end, and one in the corner, stand open/ partially boarded, wet, and damaged by foliage/ vines.

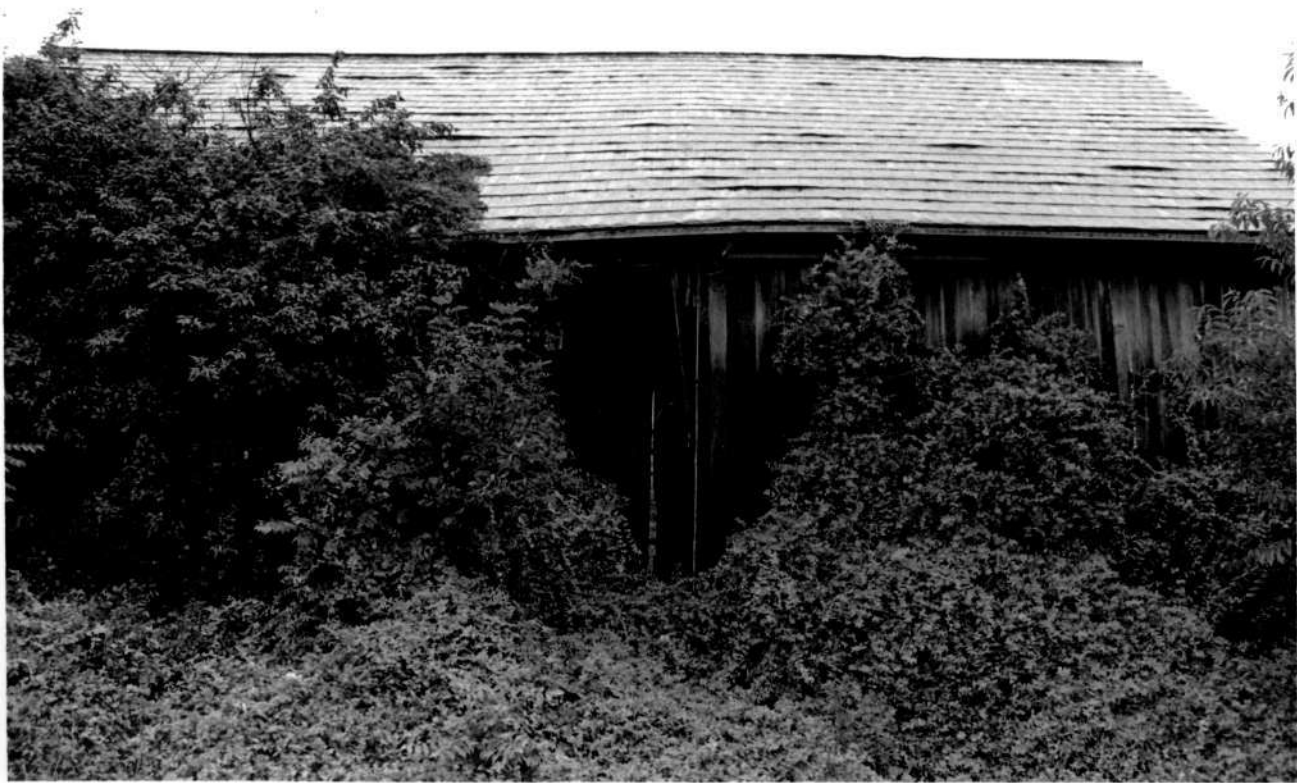
7 OF 9

BANK BARN - EAST FACADE

The gable roofed bank barn, approximately 70' x 35' is sited so that the uphill section faces south to the entrance driveway and the downhill section (forebay) faces the fields that are north of the house. On a fieldstone basement foundation, there are vertically sided board walls with a center wagon entry or ramp on the south façade. The doors are permanently open and vines/ trees obscure the entry ramp and envelope approximately half of the wood portion of the building. Trees grow inside and amid the foundation stones. A metal roof with relief pattern of fish scales is evident. The roof appears to be failing and swayed and the structural members deteriorated the worst on the west half of the building.

Animal stalls are located at lower level. Exterior wood siding is missing and severe weathering is evident on the north (rear) side. The structure is in deteriorated condition. A one story plywood sheathed addition of the 20th century is attached to the east façade. It appears to date approximately 1872- 1900.

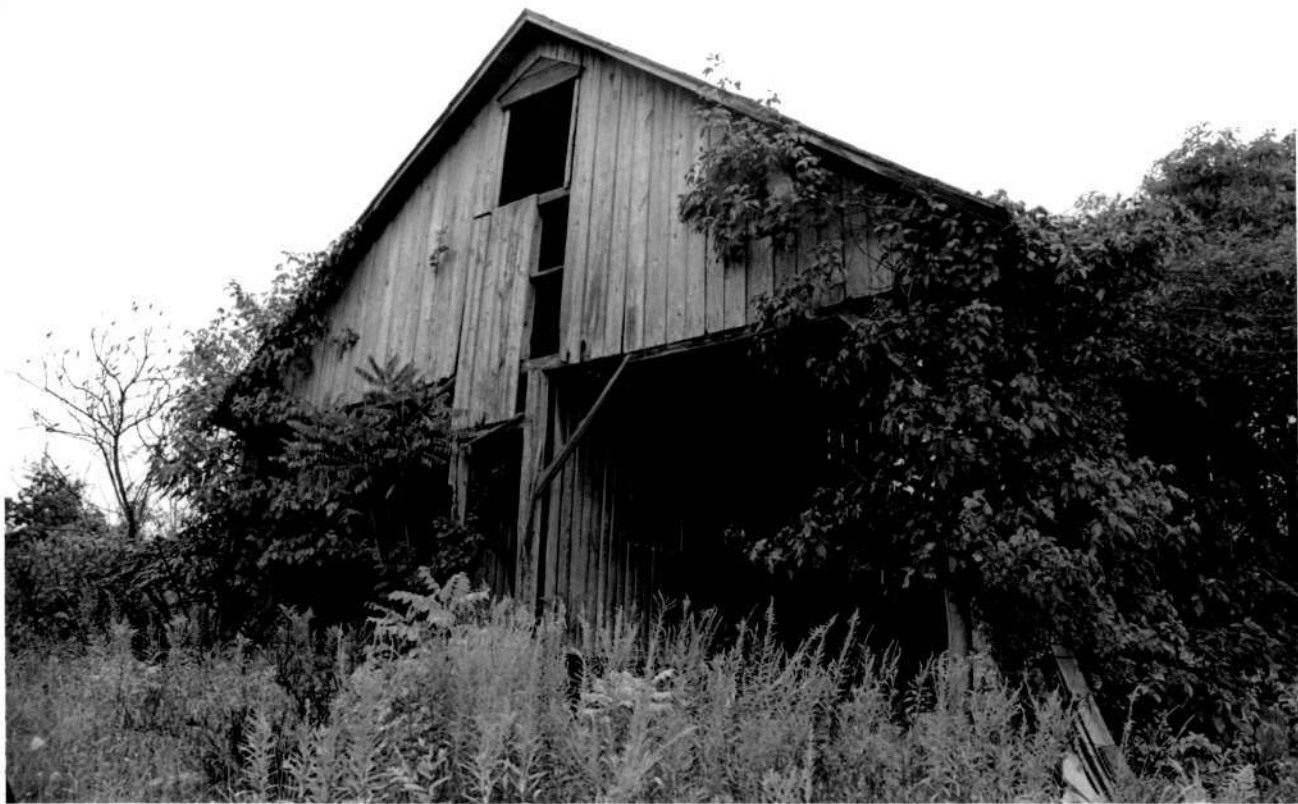
8 OF 9

CORN CRIB/WAGON SHED - NORTH FACADE

A gable roofed wood wagon shed/ corn crib is located approximately 30-40' south and west of the bank barn, aligned so that the gable faces the house and the curving driveway. The vertically wood sided structure is approximately 33' x 36' and unusual in that the center bay is the corn crib and the two end bays are wagon sheds. Constructed on a rubble stone foundation, the joined members are hand adzed, there is no flooring in the wagon sheds. The roofing is standing seam metal. In the corn crib, a narrow door is located in the center bay of the east facade, above which is a narrow gable window with a simple pediment shaped lintel. In the vertically slatted walls there is a second wood slatted door, located on each side of the corncrib, in each of the wagon shed bays. The southernmost wagon bay is partially collapsed; siding is 80% missing from the outside walls of the wagon bays. Vines and small trees are growing into and up the foundation and into the building. The building is in fair/ deteriorated condition. It appears to date approximately 1872-1900.
